# CONVEYOR PULLEYS

Supply, refurbishment & lagging

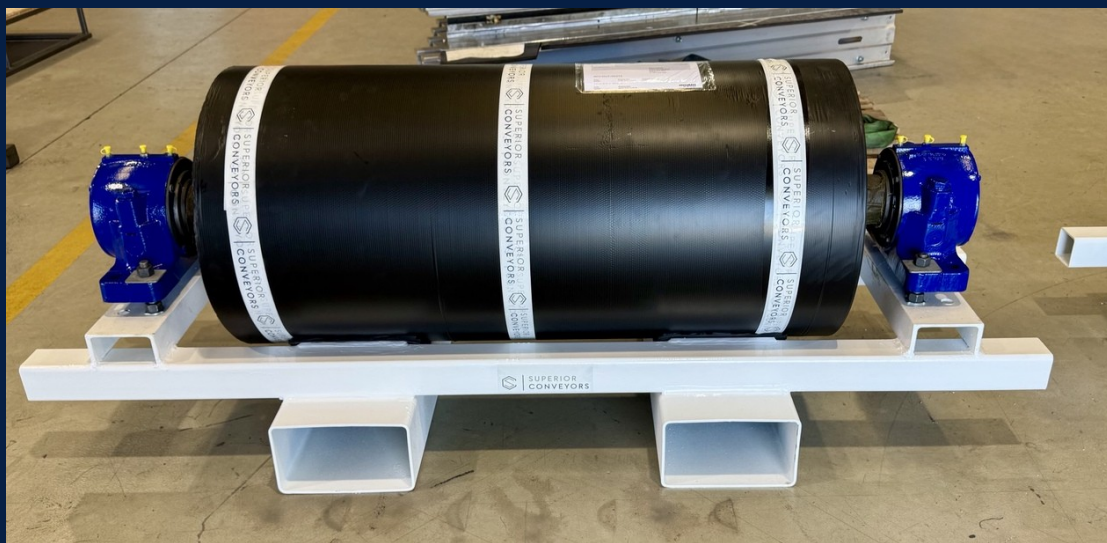
Completed pulley assembly on a transport cradle in the Mackay workshop.

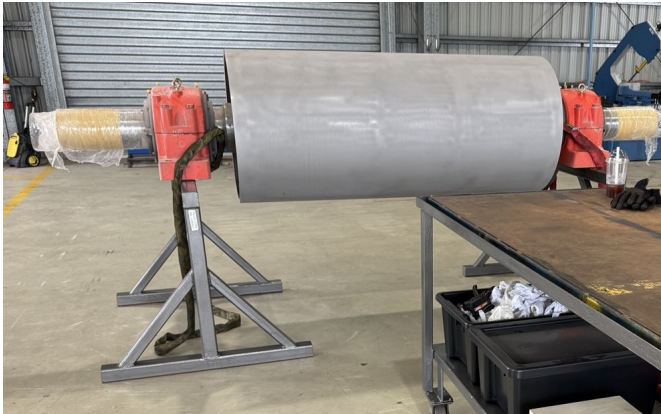
Bare pulley shell in the workshop.

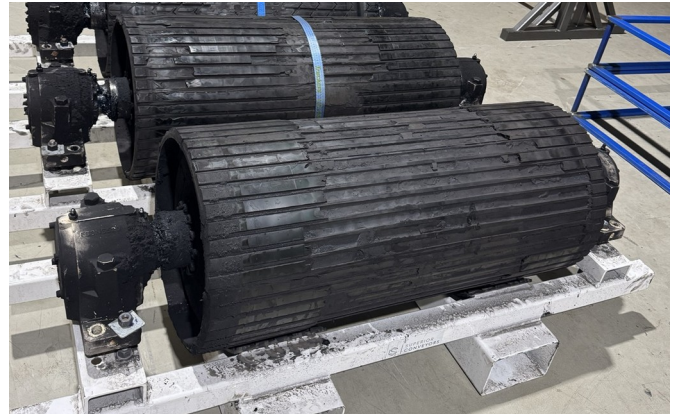
Pulley assemblies in the workshop.

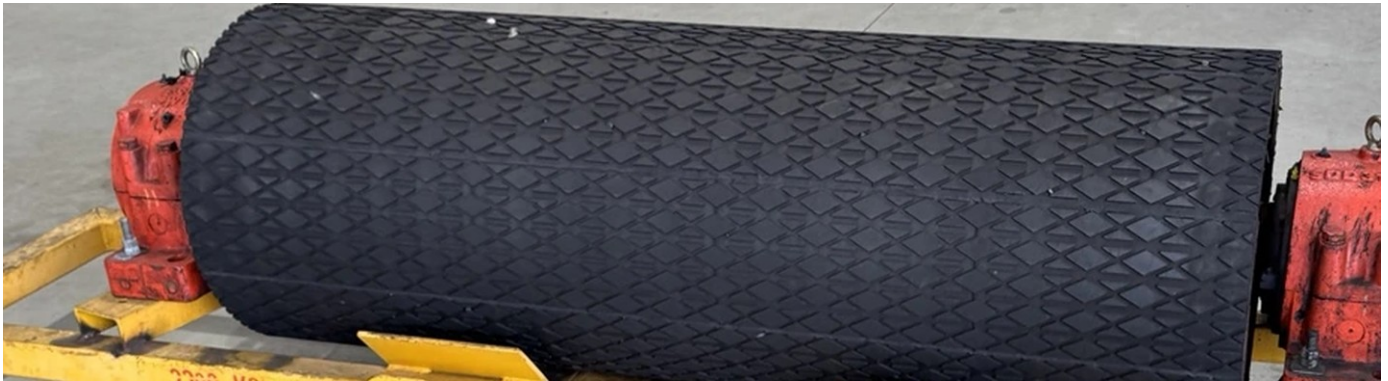
A resilient contact surface with a range of compounds and groove patterns. Rubber remains good value where it provides adequate grip and acceptable wear life.

Diamond-pattern lagging on a pulley in the Superior workshop.

Grooves channel water and fines away from the belt contact. Select the groove pattern for the pulley position and direction of travel; packed grooves cannot drain effectively.

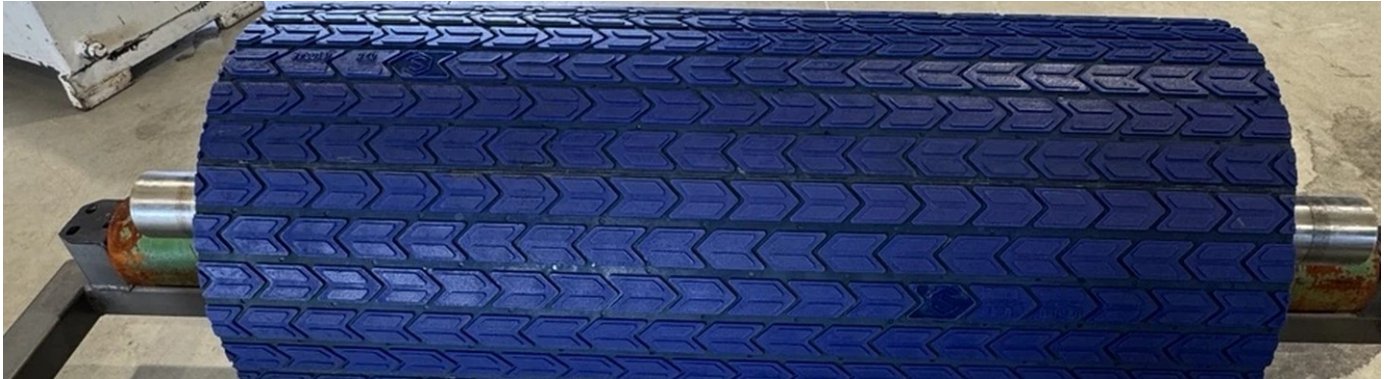
Abrasion resistance and material shedding for suitable non-drive applications. Select the grade and construction for the actual belt contact.

Blue polyurethane lagging on a pulley in the Superior workshop.

A hot-cast covering avoids bonded strip joins and is finished to the required profile. Rubber-backed polyurethane strips use a different application process. Confirm the construction before re-lagging.

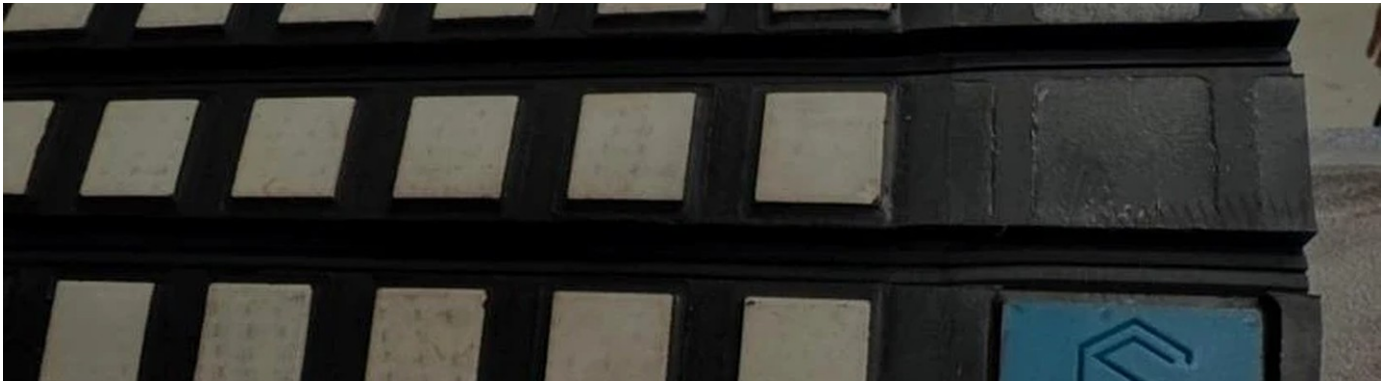
Wear-resistant tiles for drive and non-drive applications. Tile profile, coverage and backing construction must suit the belt contact and operating loads.

Ceramic tiles embedded in rubber. This photograph does not show direct-bond ceramic.

The rubber matrix supports the tiles and provides resilience. Specify coverage, spacing, drainage channels and the complete lagging-to-shell bond system.
